*In situ* cleaning of diagnostic first mirrors: an experimental comparison between plasma and laser cleaning in ITER-relevant conditions

2017 Nucl. Fusion 57 046014

# *In situ* cleaning of diagnostic first mirrors: an experimental comparison between plasma and laser cleaning in ITER-relevant conditions

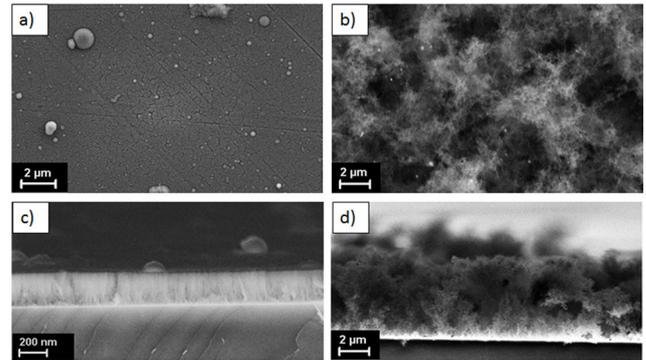
**Figure 2.** SEM micrographs of the Al/W/O contaminants. (a) and (c) plane view and cross section of compact Al/W/O (b) and (d) plane view and cross section of porous Al/W/O.

foam-like structure. The average thickness was 1  $\mu\text{m}$ . Compact Al/W/O films (mean thickness of about 250 nm) showed a relatively flat surface with some micrometric droplets and sub-micrometric cracks (figures 2(a) and (c)). The morphology of porous Al/W/O (figures 2(b) and (d)) was characterized by a very open structure with a significant amount of voids. In this case the average thickness was about 2.5  $\mu\text{m}$ .

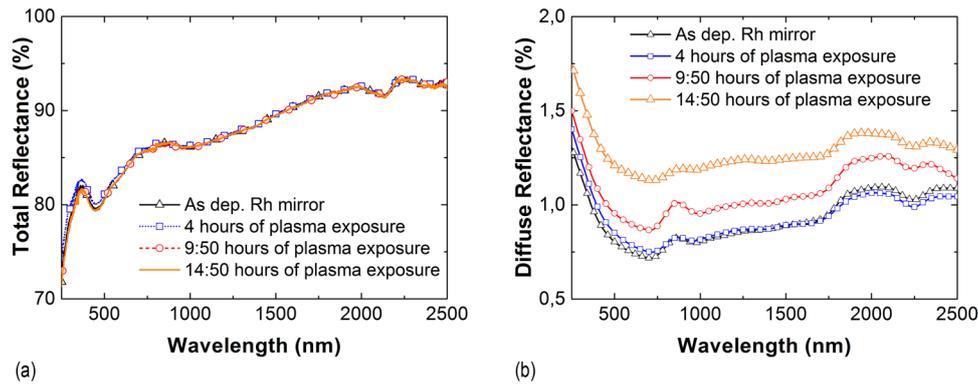
**Figure 3.** (a)  $R_{\text{tot}}$  of a Rh mirror before plasma exposure (black triangles), after 4 h of plasma treatment (blue squares), after 9.5 h of plasma treatment (red circles), and after 14.5 h of plasma treatment (solid orange). (b)  $R_{\text{diff}}$  of a Rh mirror before plasma exposure (black triangles), after 4 h of plasma treatment (blue squares), after 9.5 h of plasma treatment (red circles), and after 14.5 h of plasma treatment (solid orange).

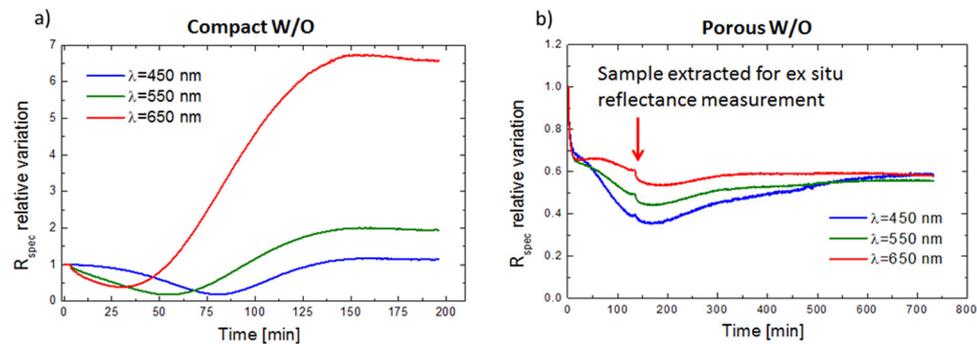
**Figure 4.** Evolution of relative specular reflectance as a function of accumulated plasma exposure time for: (a) mirror contaminated with compact W/O (b) mirror contaminated with porous W/O. Relative  $R_{\text{spec}}$  is evaluated at  $\lambda = 450$  nm (blue line),  $\lambda = 550$  nm (green line), and  $\lambda = 650$  nm (red line). An arrow marks the point when the porous W/O sample was extracted from the chamber for an absolute measurement of its reflectance.

The time evolution of relative  $R_{\text{spec}}$  for the mirror contaminated with compact W/O during the cleaning is shown in figure 4(a). For this kind of contamination, the reflectance in

The relative  $R_{\text{spec}}$  evolution for the mirror contaminated with porous W/O followed a completely different behavior (figure 4(b)). A prompt drop in relative reflectance is observed in correspondence to the beginning of plasma treatment. About 30% of the initial reflectance was lost in a few minutes, then  $R_{\text{spec}}$  decreased with an almost constant rate. The treatment was interrupted after 2 h, and the surface composition was checked by XPS. W (total 40 at.%), O (29 at.%) and Rh (31 at.%) were detected. The W4f core level spectrum was deconvoluted in metallic (24 at.%),  $\text{WO}_2$  (7.5 at.%) and  $\text{WO}_3$  (8.5 at.%) component, thus suggesting that the plasma cleaning process reduced the oxygen content of W/O contaminant probably because O is more easily sputtered than W.

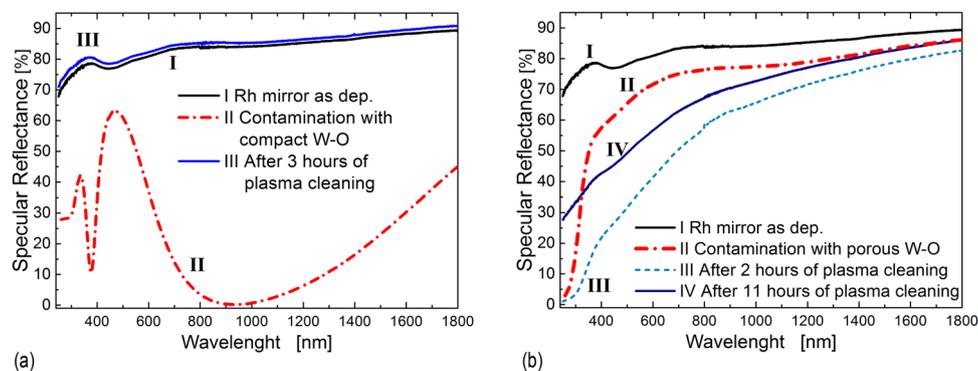
**Figure 5.** (a)  $R_{\text{spec}}$  of a Rh mirror before contamination (I, solid black), contaminated with compact W/O (II, dashed red) and after 3 h of plasma cleaning (III, solid blue). (b)  $R_{\text{spec}}$  of a Rh mirror before contamination (I, solid black), contaminated with porous W/O (II, dashed red), after 2 h of plasma cleaning (III, dashed light blue), and after 11 h of plasma cleaning (IV, solid dark blue).

the visible region was determined by thin film interference effects, as can be seen from figure 5(a) (dashed red line, II). As the plasma sputtering started to reduce the thickness of the W/O layer, the spectral positions of the reflectance maxima and minima were shifted towards shorter wavelengths. The reflectance at a certain wavelength varied correspondingly. This behavior is clearly appreciable in figure 4(a), observing that for each wavelength the reflectance has a minimum corresponding to the thickness at which destructive interference occurs. After 3 h of plasma exposure, the relative reflectance reached a stable plateau, and therefore the cleaning was stopped. SEM and XPS analyses highlighted that the mirror surface was completely free from contaminant residuals (not shown). The original  $R_{\text{spec}}$  was fully recovered, as shown in figure 5(a) (solid blue line, III).

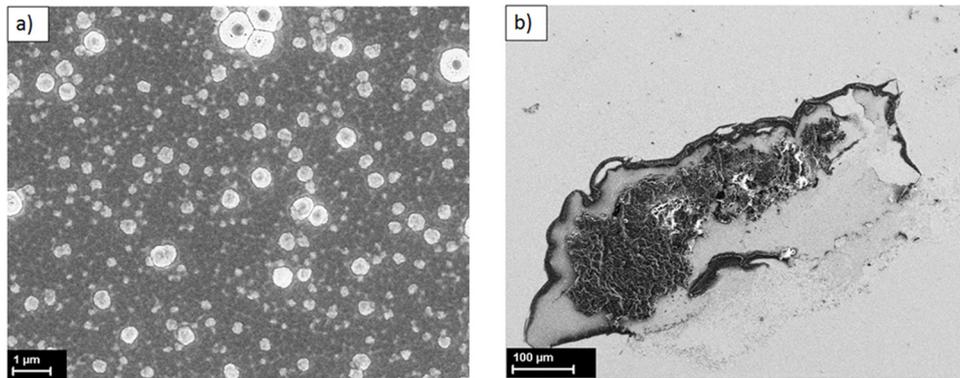
**Figure 6.** SEM top-view of the mirror contaminated with porous W/O after 12h of plasma cleaning treatment. (a) High magnification image of W/O residuals, taken from a region without macroscopic damages. (b) Low magnification image of the millimetric-wide damage site.

A SEM micrograph of the mirror surface after the cleaning treatment (12 h) is reported in figure 6. Globular-shaped residuals can be seen in figure 6(a). In figure 6(b), it is possible to appreciate a millimetric region where the Rh coating was severely damaged by the prolonged plasma exposure.

Plasma cleaning failed to recover the mirror reflectance in the case of porous contaminants (figures 16(a) and (b), blue solid line, III). The failure was dramatic for porous Al/W/O, for which the Rh mirror optical properties were completely lost. For both W/O and Al/W/O contaminations, the cleaning process caused severe damage to the Rh coating while contaminants were still present on the surface (figures 6 and 10, respectively).

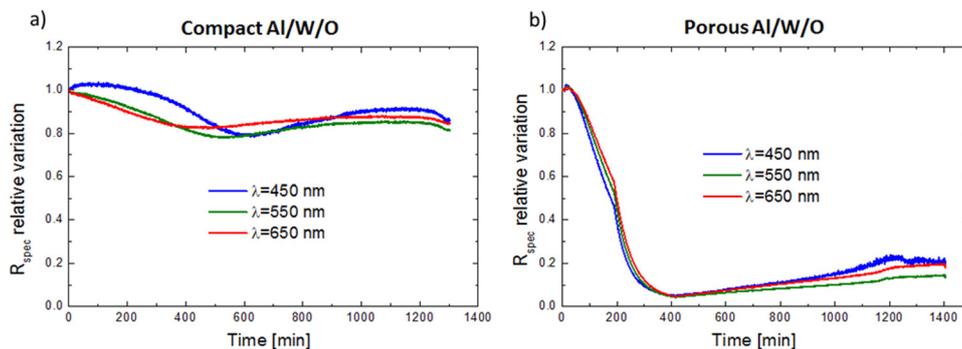
**Figure 7.** Evolution of relative specular reflectance as a function of accumulated plasma exposure time for mirrors contaminated with: (a) compact Al/W/O, (b) porous Al/W/O. Relative  $R_{\text{spec}}$  is evaluated at  $\lambda = 450$  nm (blue line),  $\lambda = 550$  nm (green line), and  $\lambda = 650$  nm (red line).

The relative  $R_{\text{spec}}$  variation of the mirror contaminated with compact Al/W/O as a function of plasma exposure time is shown in figure 7(a). As discussed for compact W/O contamination, the evolution of relative reflectance was driven by interference phenomena as long as the thickness of the Al/W/O coating was decreasing because of the plasma sputtering. Then, after about 20 h of plasma exposure, the reflectance

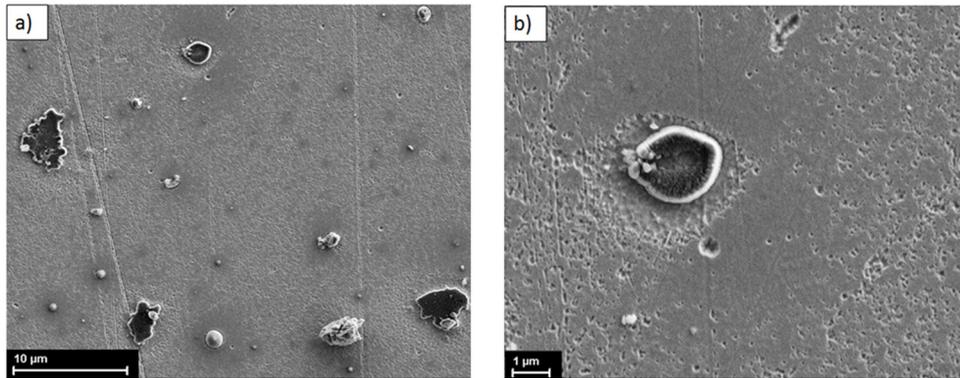
**Figure 8.** SEM top-view of the mirror contaminated with compact Al/W/O after 21 h of plasma cleaning treatment. (a) Al/W/O residuals (b) surface modifications induced by plasma exposure.

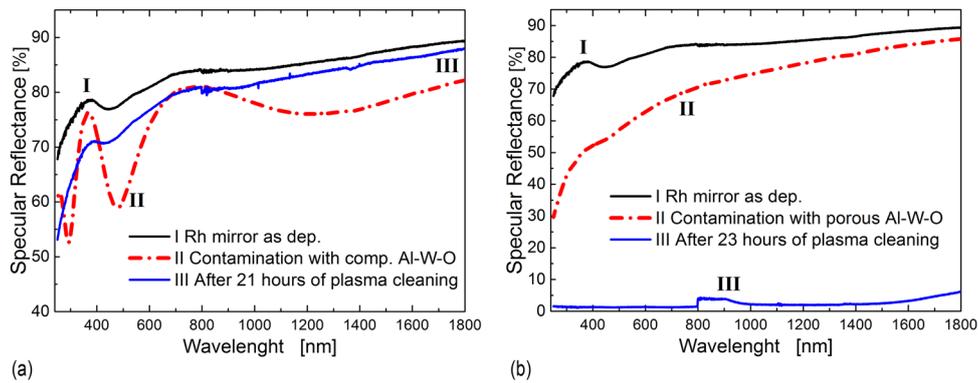
**Figure 9.** (a)  $R_{\text{spec}}$  of a Rh mirror before contamination (I, solid black), contaminated with compact Al/W/O (II, dashed red) and after 21 h of plasma cleaning (III, solid blue). (b)  $R_{\text{spec}}$  of a Rh mirror before contamination (I, solid black), contaminated with porous Al/W/O (II, dashed red) and after 23.5 h of plasma cleaning (III, solid blue).

The plasma cleaning treatment ensured a satisfactory  $R_{\text{spec}}$  recovery, as shown by the absolute reflectance measurement reported in figure 9(a). The missing  $R_{\text{spec}}$  is caused by both a decrease in  $R_{\text{tot}}$  and ( $\sim 9\%$  at  $\lambda = 250$  nm, not shown) and an increase in  $R_{\text{diff}}$  ( $\sim 6\%$  at  $\lambda = 250$  nm, not shown).

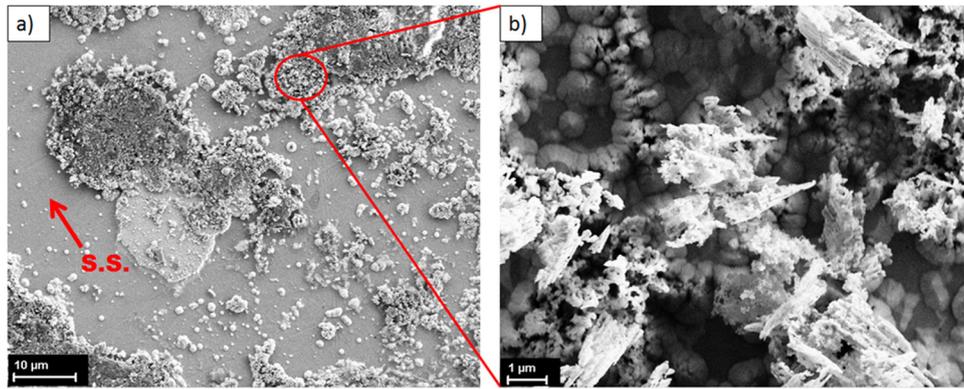
**Figure 10.** SEM top-view of the mirror contaminated with porous Al/W/O after 23.5 h of plasma exposure treatment. (a) Overview showing different residuals and SS substrate, (b) close up on the residuals.

several regions of the sample surface. An example is given in the SEM micrograph reported in figure 10(a), where the stainless steel (SS) substrate is visible. It is evident that the selected cleaning parameters (i.e. ion mass and energy) are not compatible with this combination of mirror and contaminant. Apart from the steel substrate, which preserved its smoothness, the remaining material presents the peculiar morphology shown in figure 10(b). XPS analysis revealed that it was composed of only Rh and O. Since it was not possible to detect Al signal, it can be deduced that most of the contaminant has been removed by the plasma treatment. We speculate that plasma ions have started to sputter (and eventually destroy) the Rh coating while—in other regions of the sample—contaminants were still present. Further investigations are required to understand the nature of such peculiar structures and the processes that lead to their formation.

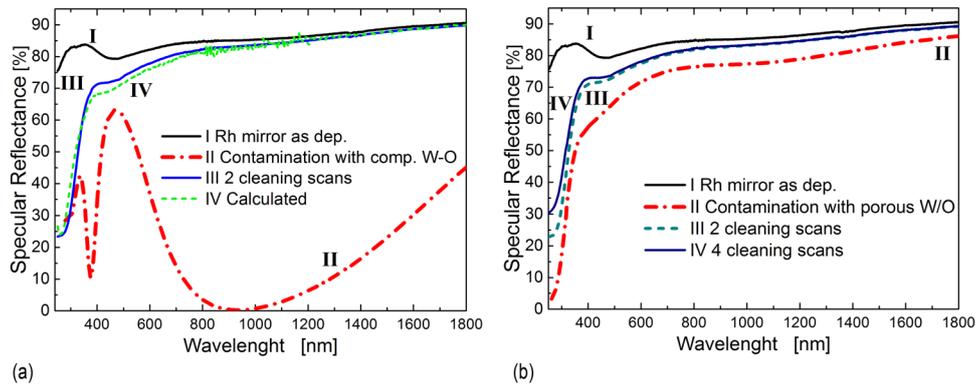
**Figure 11.** (a)  $R_{\text{spec}}$  of a Rh mirror before contamination (I, solid black), contaminated with compact W/O (II, dashed red) and after 2 laser cleaning scans (III, solid blue). The dashed green line (IV) shows the reflectance calculated by supposing a 5 nm thick WO<sub>3</sub> film (Cauchy layer with  $n = 2.17$  at  $\lambda = 550$  nm) on top of the Rh film. (b)  $R_{\text{spec}}$  of a Rh mirror before contamination (I, solid black), contaminated with porous W/O (II, dashed red), after 2 laser cleaning scans (III, dashed light blue) and after 4 laser cleaning scans (IV, solid dark blue).

In figure 11(a) we report the specular reflectance of a pristine Rh mirror (solid black line, I), of a Rh mirror contaminated with compact W/O (dashed red line, II) and of the same mirror after 2 laser cleaning scans (solid light blue line, III) are reported in figure 11(a).

Owing to the laser cleaning treatment,  $R_{\text{spec}}$  was well recovered in the NIR–vis region (>90% of the pristine value). For  $\lambda < 400$  nm, however, a sharp drop in  $R_{\text{spec}}$  is evident. This threshold wavelength corresponds to the optical band-gap of W/O contaminants, as can be estimated from dashed red lines in figures 11(a) and (b), which describe the specular reflectance of contaminated mirrors before the cleaning treatment (the optical band gap of crystalline WO<sub>3</sub> is about 2.8 eV,

The specular reflectance of the mirror contaminated with porous W/O after 2 laser cleaning scans is shown in figure 11(b) (dashed light blue line, III). It is remarkably similar to the one obtained considering the cleaning of compact W/O contamination, despite the dramatic differences in contaminant morphology and optical properties.  $R_{\text{diff}}$  was below 1% in the whole 250–1800 nm range.

After the first laser cleaning session, the same sample was cleaned again with two additional scans. The corresponding  $R_{\text{spec}}$  is plotted as the solid dark blue line (IV) in figure 11(b). By comparing dashed light blue and solid dark blue curves, we conclude that the additional cleaning cycles had a beneficial effect on the  $R_{\text{spec}}$  recovery in the UV region. The Rh coating appeared intact after the whole cleaning treatment (4 scans).

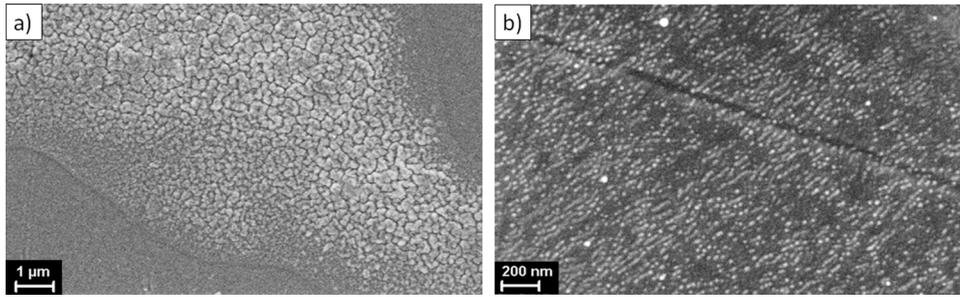
**Figure 12.** SEM top-view of: (a) compact W/O residuals after 2 laser cleaning scans, showing a peculiar, corrugated morphology (b) rod-shaped residuals from the mirror contaminated with porous W/O after 4 laser cleaning scans.

SEM analysis (figure 12(a)) revealed that some regions of the sample were covered by residuals having a morphology very different from that of non-irradiated compact W/O (figure 1(a)). In addition, XPS analysis confirmed the presence of a  $\text{WO}_3$  layer on the mirror surface. The thickness of the residual layer can be estimated by evaluating its impact on the reflectance after the laser cleaning. Line IV (dashed green) in figure 11(a) shows the calculated reflectance of a semi-infinite Rh substrate with a 5 nm thick  $\text{WO}_3$  film on top. The refractive index of the film was estimated by means of ellipsometry measurements [37] performed on another (not irradiated) W/O contaminated Rh mirror using the Cauchy's model [37]. The excellent matching between the experimental and theoretical reflectance values confirms that the UV reflectance drop after the cleaning process should be attributed to a very thin  $\text{WO}_3$  layer that remained on the mirror surface. The measured  $R_{\text{diff}}$  (not shown) was below 1% in the whole wavelength range.

rod-shaped clusters (figure 12(b)). Also in this case, EDXS and XPS detected the presence of  $\text{WO}_3$ , which is likely responsible for the low UV reflectance.

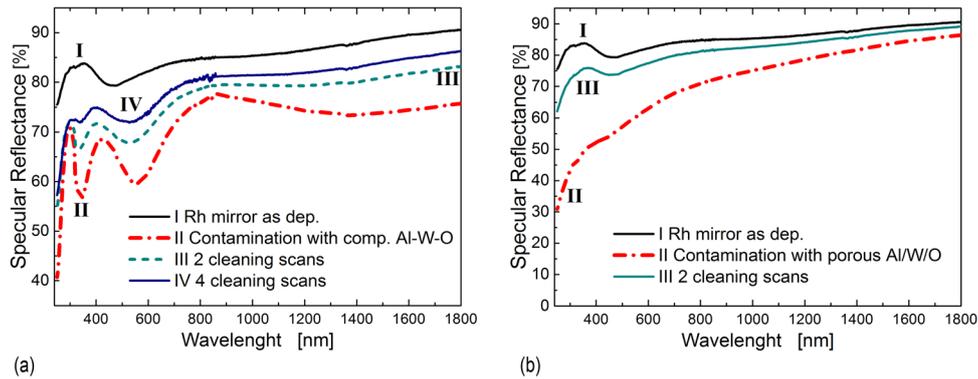
**Figure 13.** (a)  $R_{\text{spec}}$  of a Rh mirror before contamination (solid black), contaminated with compact Al/W/O (dashed red) after 2 laser cleaning scans (dashed light blue) and after 4 laser cleaning scans (solid dark blue). (b)  $R_{\text{spec}}$  of a Rh mirror before contamination (solid black), contaminated with porous Al/W/O (dashed red) and after 2 laser cleaning scans (solid light blue).

The mirror contaminated with the compact Al/W/O deposit was initially cleaned with 2 laser scans. After that, some macroscopic residuals were visible by naked eye. The corresponding  $R_{\text{spec}}$  is shown as the dashed light blue line (III) in figure 13(a). The same sample was irradiated again with two additional laser scans with the aim of increasing the cleaning efficacy. The specular reflectance after 4 cleaning cycles is reported as the solid dark blue line (IV) in figure 13(a). The loss in  $R_{\text{spec}}$  with respect to a pristine mirror varies from 5% ( $\lambda > 700$  nm) to 15% ( $\lambda = 250$  nm). The presence of an interference pattern is still visible.

The specular reflectance of the mirror contaminated with porous Al/W/O after 2 cleaning scans is shown in figure 13(b), solid light blue curve. The laser cleaning treatment ensured a satisfactory recovery of the mirror reflectance over the whole spectrum, ranging from 95% of the original value for  $\lambda > 400$  nm to 82% of the original value for  $\lambda = 250$  nm.

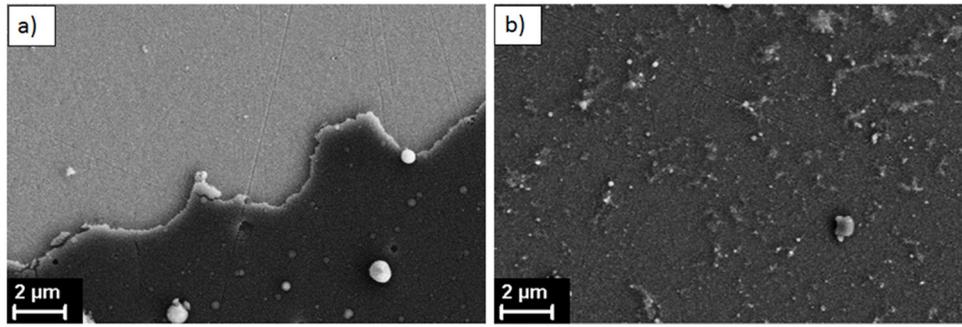
**Figure 14.** SEM top-view of: (a) compact Al/W/O residuals after 4 laser cleaning scans. Rh coating appears as the brighter region. (b) Porous Al/W/O residuals after 2 laser cleaning scans.

SEM analysis (figure 14(a)) clearly shows the presence of regions in which the contaminant film is still integer and adherent to the Rh coating. On the other hand, there are some areas that seem totally cleaned. XPS surface analysis revealed the presence of Al (22 at.%) and O (42 at.%), together with a

As shown in figure 14(a), there is a sharp transition between the zone where the contaminant film is present and the cleaned one, as if the film underwent a brittle fracture. This fact suggests that laser induced thermo-mechanical stresses may have played a major role in contaminant removal. No damages of the Rh coating were observed.

SEM microscopy revealed that the Rh surface covered by Al/W/O porous structures was strongly decreased thanks to laser cleaning (figure 14(b)). As a consequence, the fraction of light randomly scattered from contaminant is diminished and the reflection from Rh film at the specular angle is increased.

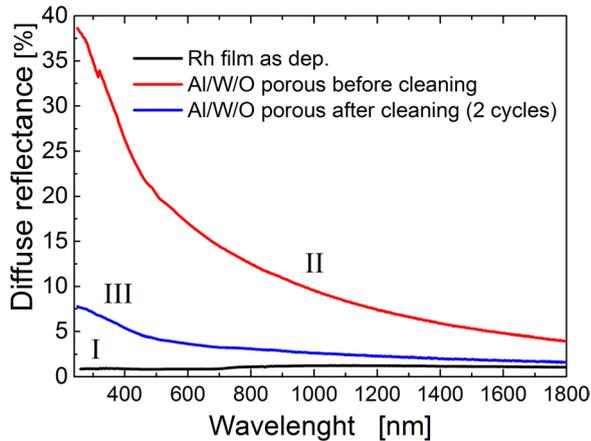
**Figure 15.**  $R_{\text{diff}}$  of a bare Rh mirror as deposited (I, black), after contamination with porous Al/W/O (II, red), after 2 scans of laser cleaning (III, blue).

By comparing the diffuse reflectance before (figure 15, line II red) and after the laser cleaning (figure 15, line III blue), it is clear that the recovery in  $R_{\text{spec}}$  was essentially due to a decrease in  $R_{\text{diff}}$  as a consequence of the cleaning process.

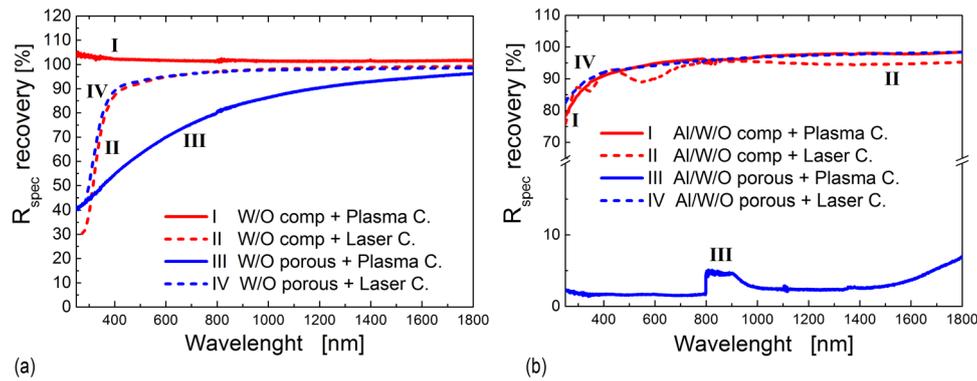
**Figure 16.** (a)  $R_{\text{spec}}$  recovery as a result of the plasma cleaning (solid lines) and laser cleaning (dashed lines) processes in the case of W/O contaminants. (b)  $R_{\text{spec}}$  recovery as a result of the plasma cleaning (solid lines) and laser cleaning (dashed lines) processes in the case of Al/W/O contaminants.

Because of inherent differences in the characteristics of the two spectrophotometers employed to measure the reflectance after the cleaning treatments, the cleaning results are compared in terms of  $R_{\text{spec}}$  recovery, defined as the ratio of pristine specular reflectance (i.e. before contamination) to the reflectance after cleaning, both measured with the same equipment. The  $R_{\text{spec}}$  recovery is shown in figures 16(a) and (b) for W/O and Al/W/O contaminants, respectively.

In particular, in the case of compact W/O, the contaminant was completely removed, the mirror's surface was not altered by the plasma treatment, and the reflectance was slightly higher than the original value over the entire spectrum (figure 16(a), red solid line, I). In the case of compact Al/W/O contamination, the presence of some micrometric residuals and the roughening of the mirror surface can explain the incomplete  $R_{\text{spec}}$  recovery ( $\approx 80\%$ ) in the UV region (figure 16(b), red solid line, I). SEM analysis showed that the quality of the mirror surface was deteriorated by the plasma treatment (figure 8(b)). This degradation might evolve in a severe mirror damaging in the case of repeated plasma cleaning cycles.

Laser cleaning proved to be much less sensitive to the contaminant morphology than plasma cleaning. For all the contaminations considered, the same laser cleaning procedure ensured a very good  $R_{\text{spec}}$  recovery (>90%) in the vis-NIR spectral range. This appears clearly by comparing the  $R_{\text{spec}}$  recovery achieved for porous and compact morphologies (red dashed line II and blue dashed line IV, respectively) in figure 16(a) (W/O contaminant) and figure 16(b) (Al/W/O contaminant). The robustness of the adopted laser cleaning procedure with respect to the contaminant characteristics (e.g. morphology and thickness) is especially valuable in the view of remote operations, since in principle one can perform the cleaning without characterizing in advance the status of the mirror's surface to be treated.

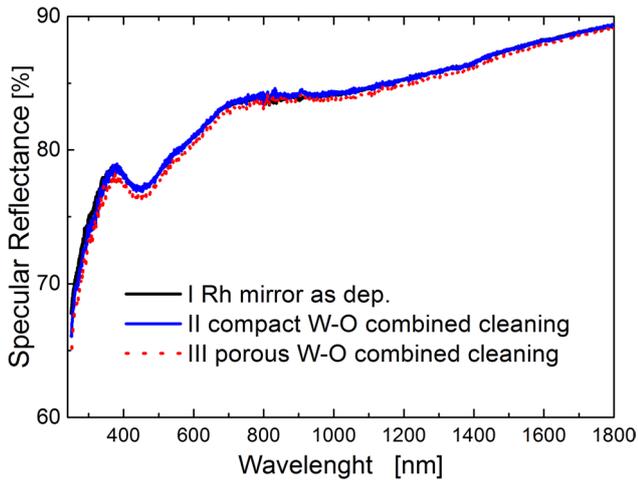
**Figure 17.**  $R_{\text{spec}}$  of a Rh mirror before contamination (I, black); contaminated with compact W/O after 2 laser cleaning scans and 45 min of plasma cleaning (II, blue); contaminated with porous W/O after 4 laser cleaning scans and 45 min of plasma cleaning (III, red).

The feasibility of this solution was tested on the mirrors that were previously contaminated with compact and porous W/O and laser cleaned as described in section 3. The mirrors were subsequently exposed for 45 min each to the same plasma conditions described in section 4. For both samples, the XPS analysis performed after the final plasma cleaning session detected only Rh and O, indicating a complete removal of contaminants. The resulting specular reflectance is coincident with the pristine value, as can be appreciated in figure 17. In particular, the combined cleaning approach ensured a complete recovery of the mirror properties also in the UV region (where laser cleaning alone was not sufficient, see blue lines in figures 11(a) and (b)) and for porous contamination (very hard to treat by plasma cleaning alone). Furthermore, the time required for the combined cleaning is reduced by a factor of
